G8813.03-303-11-R0
ACOUSTICAL PERFORMANCE TEST REPORT
ASTM E90

NEON ENERGY

Series/Model: ULTRA

Type: Fixed Window

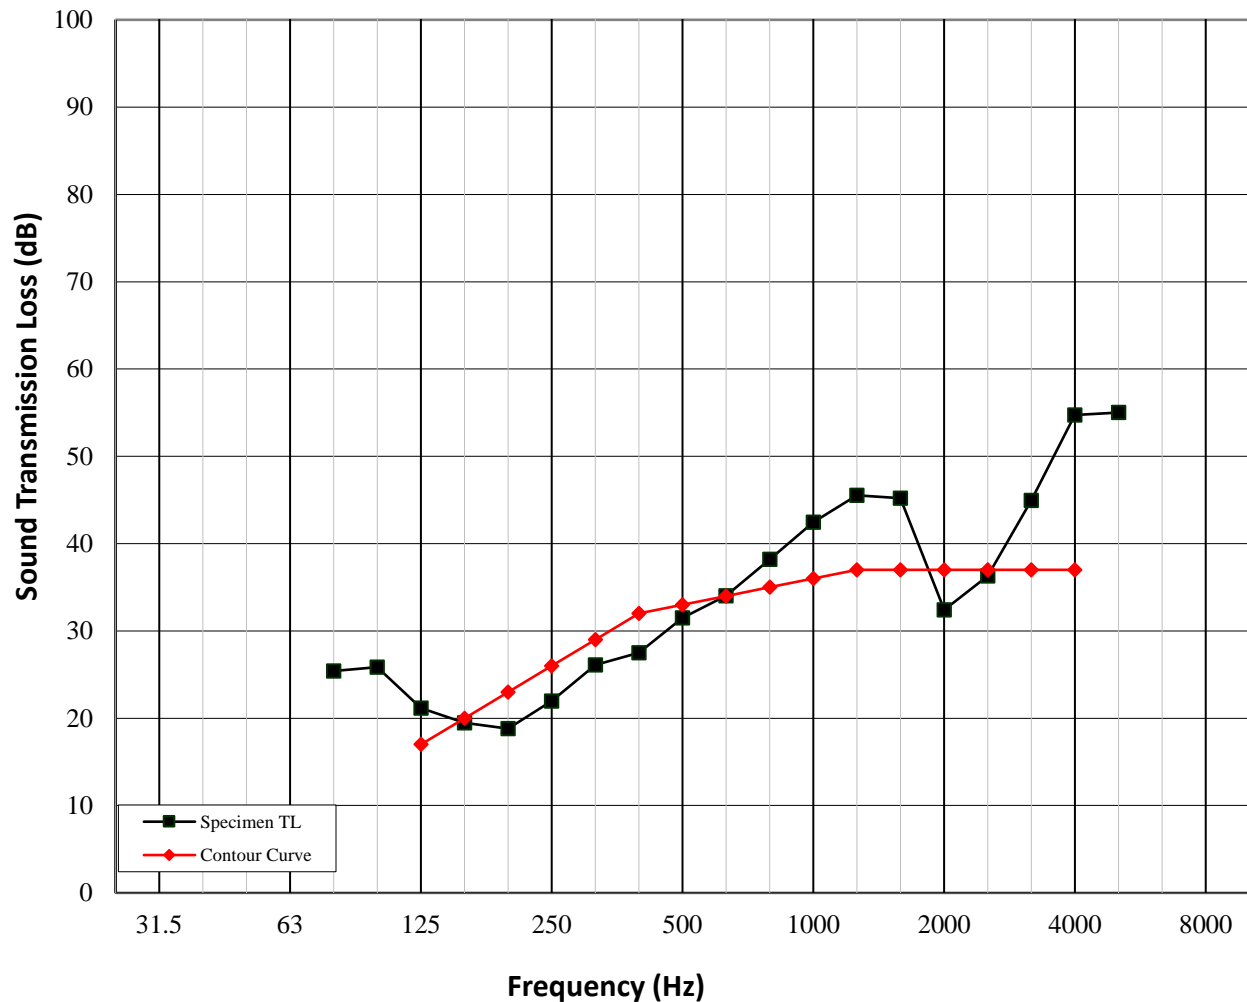
Airborne Sound Transmission Loss

STC Rating	33	(Sound Transmission Class)
Deficiencies	25	(Sum of Deficiencies)
OITC Rating	27	(Outdoor-Indoor Transmission Class)
Rw Rating	33	(Sound Reduction Index)

Test Date	03/27/17					
Data File No.	G8813.03					
Client	Neon Energy					
Description	Series/Model: Ultra Fixed Window with 27 mm (1") IG (6 mm (1/4") tempered interior, 16 mm (5/8") air space, 5 mm (1/4") annealed exterior)					
Specimen Area	1.80 m ²	Receive Temp.	20.7 °C		Source Temp.	20.9 °C
Technician	Leeland S. Hoov	Receive Humidity	52%		Source Humidity	52%

Freq (Hz)	Background SPL (dB)	Absorption (m ²)	Source SPL (dB)	Receive SPL (dB)	Specimen TL (dB)	95% Confidence Limit	Number of Deficiencies
80	39.9	4.7	104	75	25.4	1.46	-
100	35.7	4.9	105	76	25.8	1.50	-
125	41.4	5.2	105	79	21.2	1.31	0
160	44.9	5.3	103	79	19.5	0.67	1
200	38.0	6.1	106	81	18.8	0.89	4
250	23.9	6.8	106	78	22.0	0.46	4
315	18.1	6.6	106	75	26.1	0.36	3
400	18.6	5.8	107	75	27.5	0.52	5
500	21.4	5.2	108	72	31.5	0.50	2
630	16.6	5.6	106	67	34.0	0.34	0
800	18.5	5.7	106	62	38.2	0.29	0
1000	9.6	5.9	108	60	42.4	0.19	0
1250	7.0	6.0	106	56	45.5	0.24	0
1600	5.7	6.5	104	53	45.2	0.24	0
2000	6.5	7.5	102	63	32.4	0.26	5
2500	5.9	8.4	102	59	36.3	0.22	1
3150	5.2	9.5	101	49	45.0	0.26	0
4000	5.4	11.5	99	36	54.7	0.33	0
5000	5.7	14.6	99	35	55.0	0.41	-
